**MISSAN SURGICAL HOSPITAL**  
**UNDER THE ECONOMIC SUPPORT FUND**  
**AL AMARAH, IRAQ**

**SIGIR PA-08-165**  
**SIGIR PA-08-167**

**JULY 16, 2009**

## Summary of Report: PA-08-165 and PA-08-167

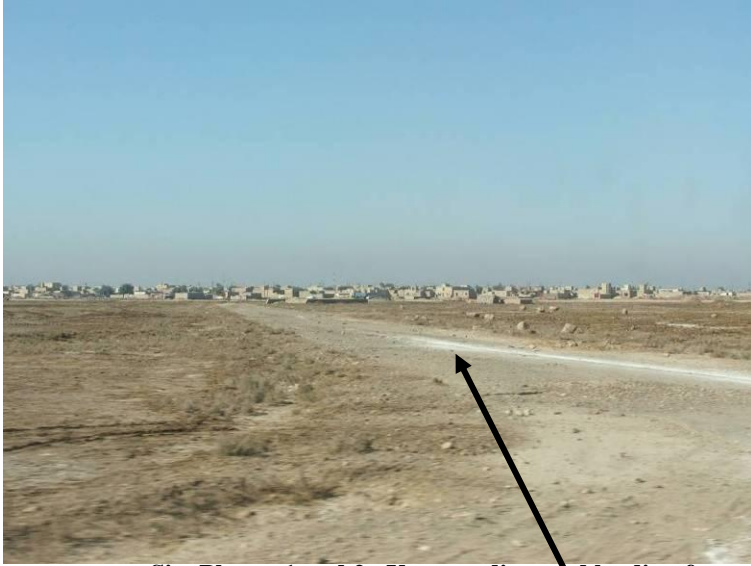
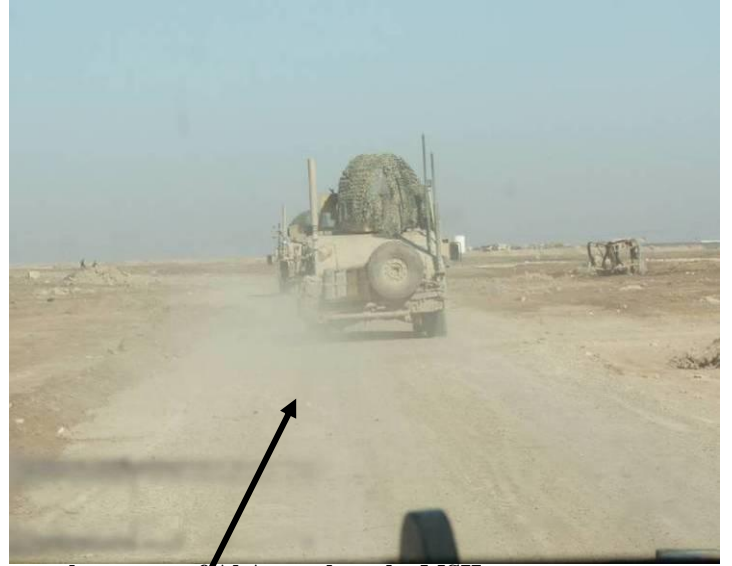
**Site Photos 1 and 2. Uneven, dirt road leading from the northern part of Al Amarah to the MSH**

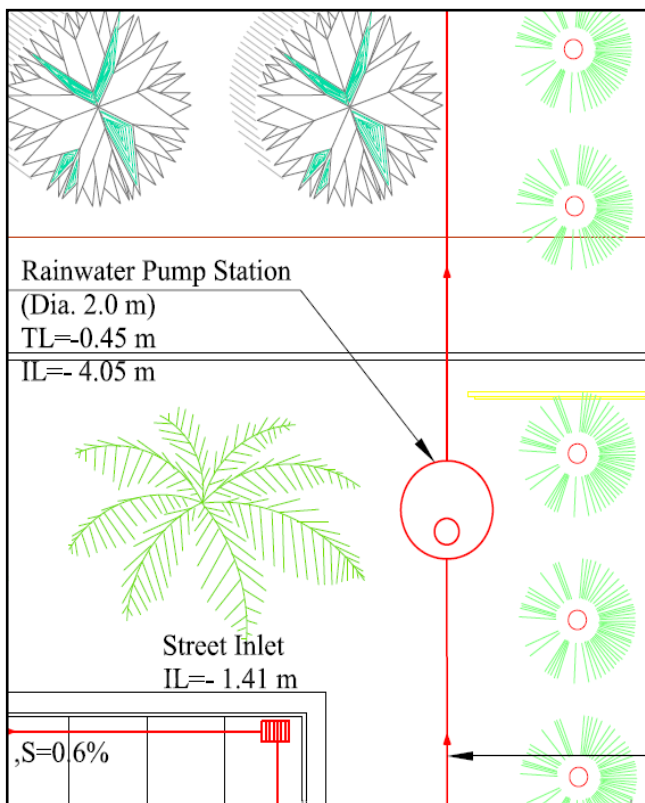
**Figure 6. Storm water pump station plan**

The contractor's plans lacked adequate information for SIGIR to determine how the pumps are controlled or how they will address low-flow conditions. SIGIR is concerned that the high capacity of the pumps combined with the small size of the wet well may result in a rapid cycling of the pumps leading to overheating and premature pump failure.

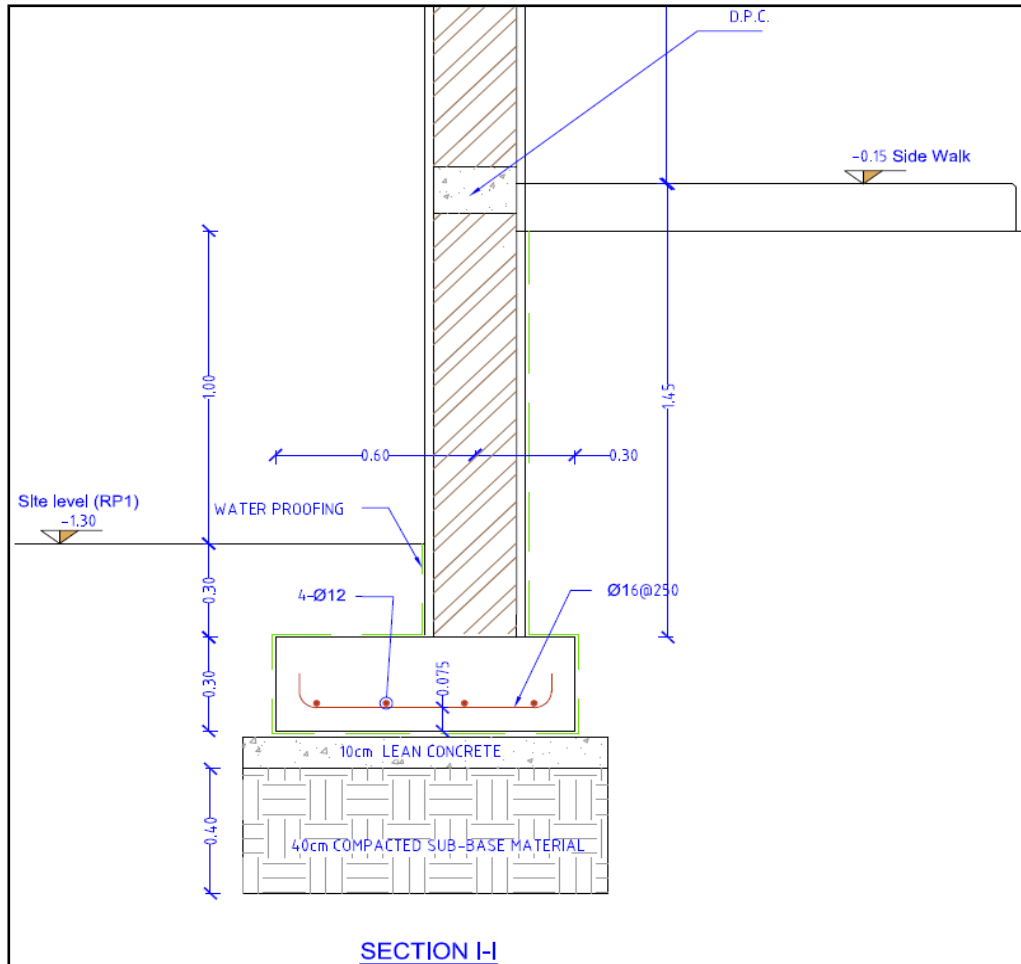
**Figure 8. Perimeter retaining wall section**

The contractor's design plan detailed the perimeter fence along the north edge of the project site. The plan indicated the application of waterproofing to the portion of the wall below grade (Figure 8). However, the application of waterproofing without the integration of subsurface drainage behind the wall may allow for the buildup of hydrostatic pressure against the wall and possible localized failure of the brick infill.

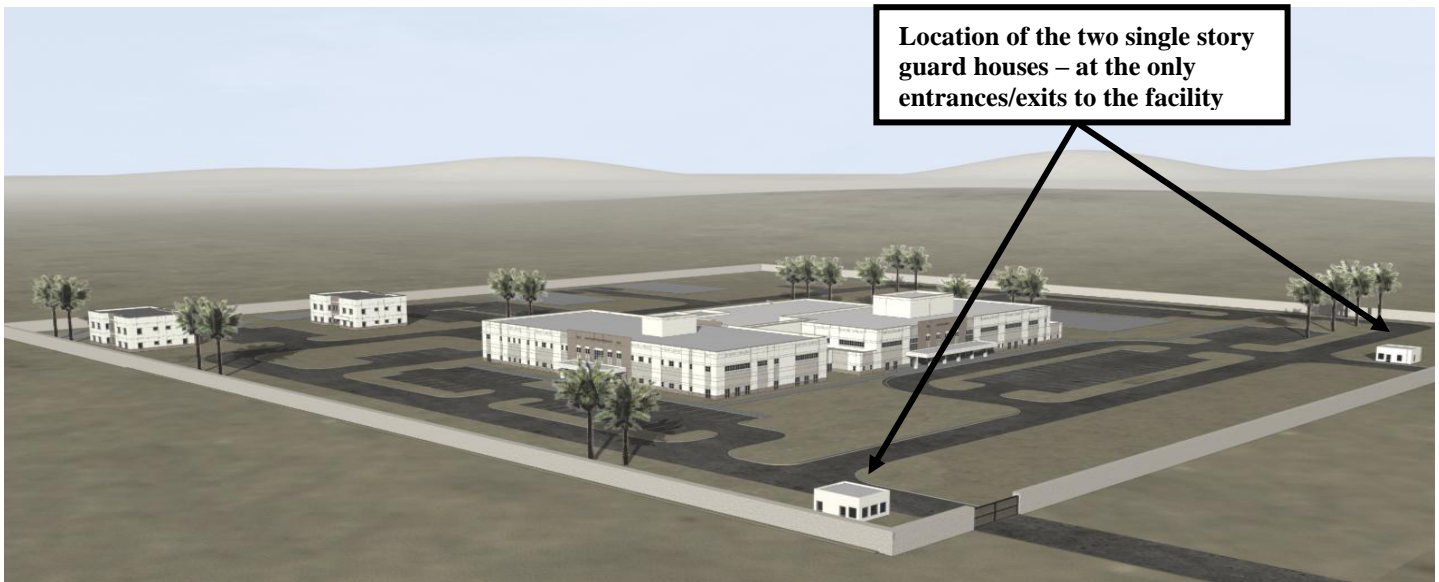
**Figure 9. Location of the two guard houses for the MSH (Courtesy of GRS)**

from the guard house, additional guard houses and elevated guard towers are necessary to provide adequate security.

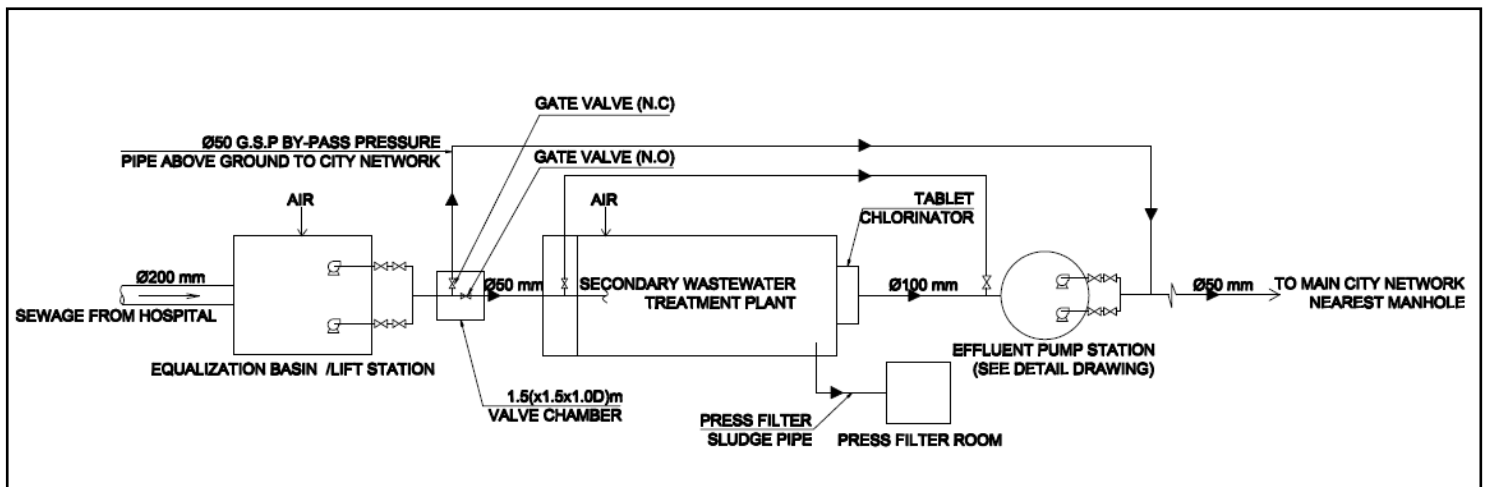
Figure 14. Contractor's overall wastewater treatment plant schematic drawing (Courtesy of GRS)

Similar to the water supply system, the wastewater system design lacked significant details, such as the alignment and outfall of the sewage leaving the hospital site. Figure 14 shows the overall wastewater treatment plant schematic drawing, which indicates that the sewage leaving the hospital will be deposited directly into the “main city network nearest manhole” without identifying the exact location and distance to the nearest manhole, the size, elevation, and condition of the main city network sewer pipe, and whether or not an analysis has been performed to determine if the existing city network system can accommodate the significant additional flow the hospital will provide. To ensure that sewage does not back up into the hospital or in nearby neighborhoods, it is important that the network have the capacity to handle the additional flow.

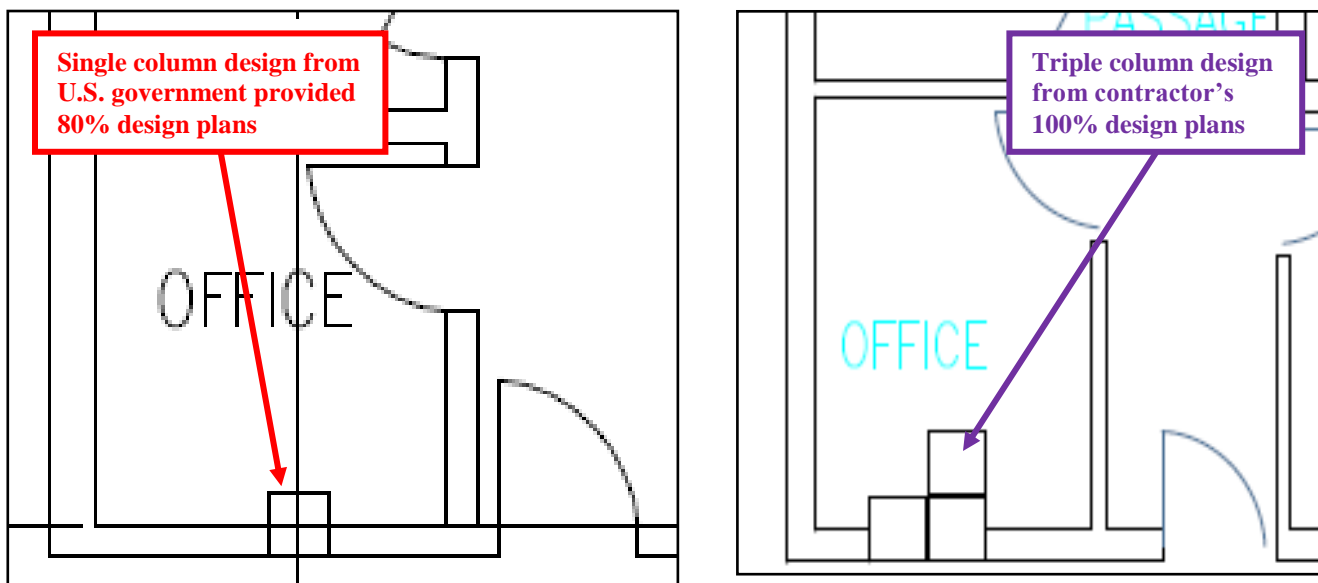
The design drawings include a structure layout with additional columns to accommodate expansion joints in the building. While the floor plans were adjusted to accommodate the additional columns, there appeared to be spatial conflicts in several of the rooms. For example, Figure 15 is the original floor plan (80% design), which allocated a 0.5 m x 0.5 m column in this office; while Figure 16 is the contractor's re-design, which added the expansion joint and two additional 0.5 m x 0.5 m columns for the same office. Although the contractor made the office larger to compensate for the undesirable use of space, the additional columns render the office less efficient and aesthetic than if the floor plan was modified to place the columns in less obtrusive locations. SIGIR observed this in several locations.

**Figures 15 and 16. The contrast between the 80% design single column configuration (left) and the contractor's triple column configuration (right). The triple column configuration is less efficient space wise and less aesthetically pleasing. (Courtesy of GRS)**

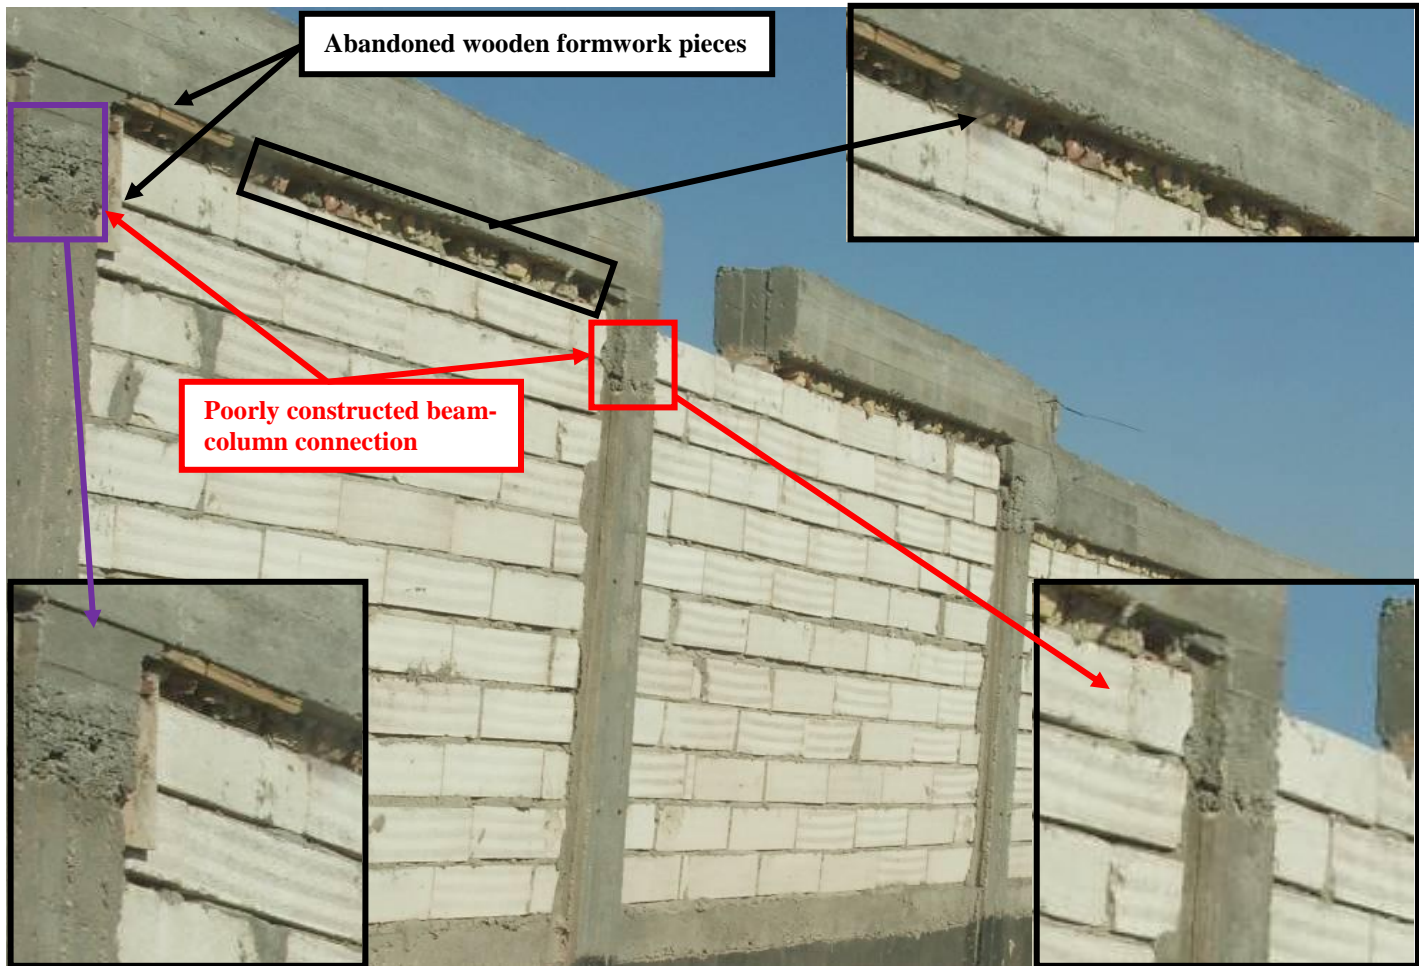
Site Photo 3. Perimeter security wall construction

At the time of the site visit, the perimeter wall appeared adequate as a deterrent to anyone attempting to unlawfully enter the compound; however, the concerns identified by SIGIR regarding the wall's construction will ultimately affect the wall's long term sustainability.

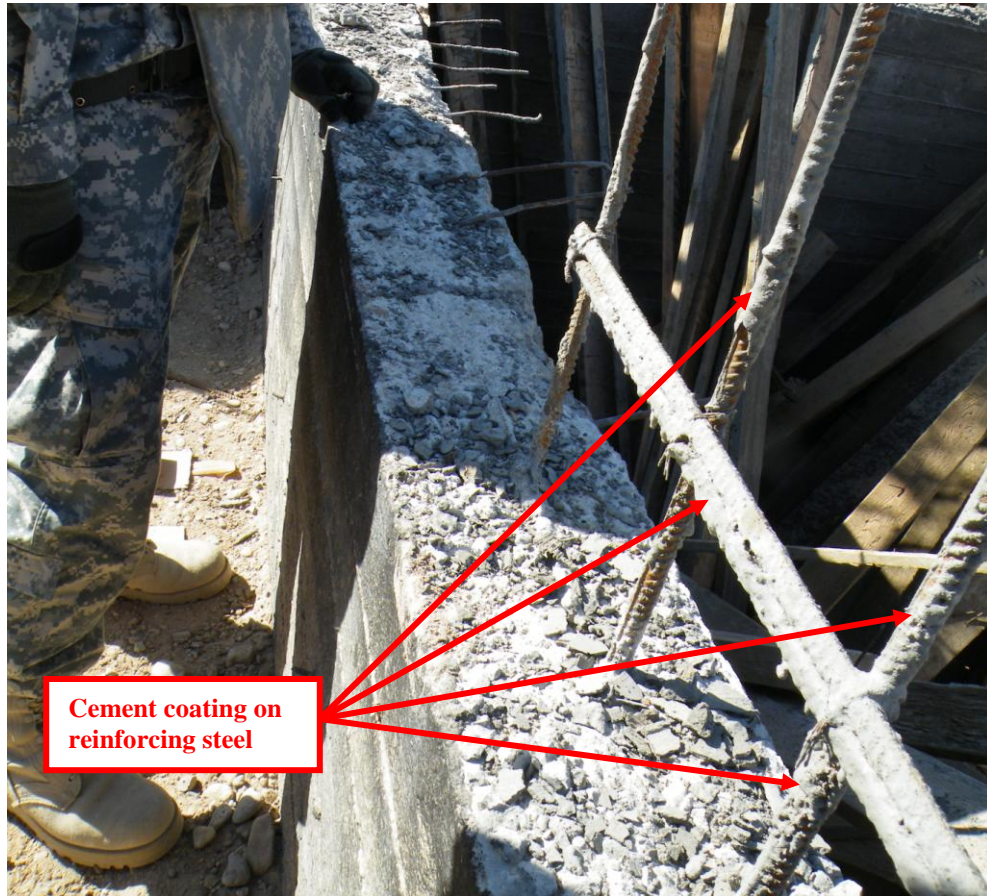
Due to time limitations on site, SIGIR did not have the opportunity to analyze the reinforcing steel inside the formwork to determine if this issue was being rectified prior to concrete pouring operations.

**Site Photo 4. Cement coating on reinforcing steel**

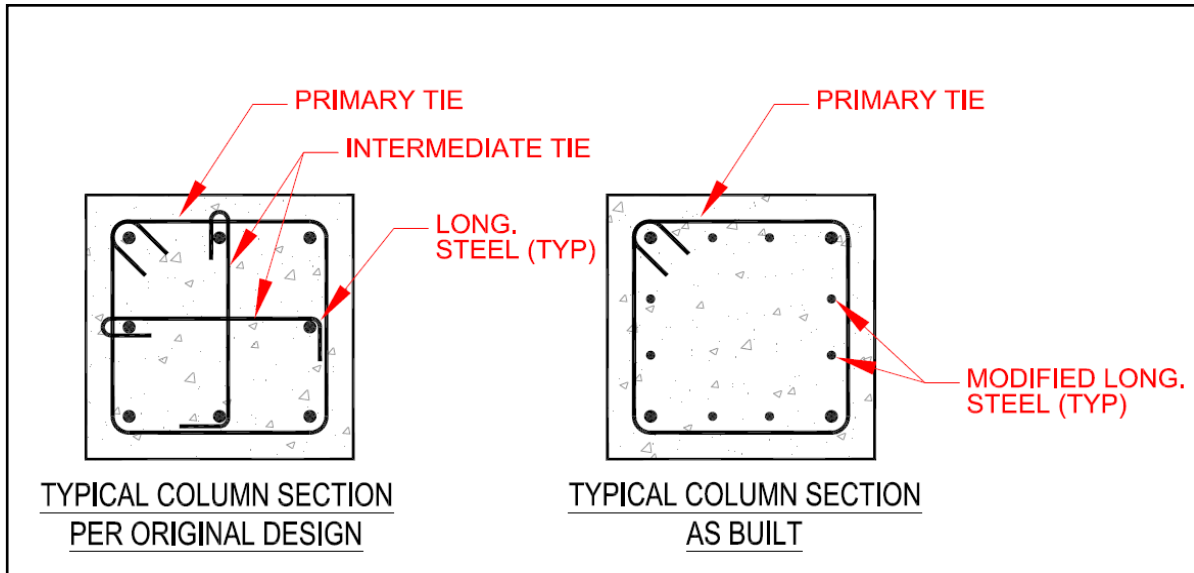
**Figure 17. Comparison of typical design column section versus column as constructed**

In addition, SIGIR noted that the reinforcing configuration used in the construction of the reinforced concrete columns varied from the configuration specified in the design drawings. Figure 17 clearly illustrates the difference between the design drawing and actual construction of the reinforcing configuration. The design drawing required three separate pieces of reinforcement bar along with two ties (primary and intermediate). The primary ties a steel bar around the perimeter of the vertical reinforcement bars; while the intermediate ties a steel bar from the middle reinforcement bar of one side to the other. However, the contractor opted to use four vertical pieces of reinforcement bar along with a primary tie around the perimeter.

In order to more clearly illustrate the difference in the design versus actual construction, Figure 17 is the reinforcement configuration from the design drawings; while Figure 17 and Site Photo 5 document the actual construction performed by the contractor.

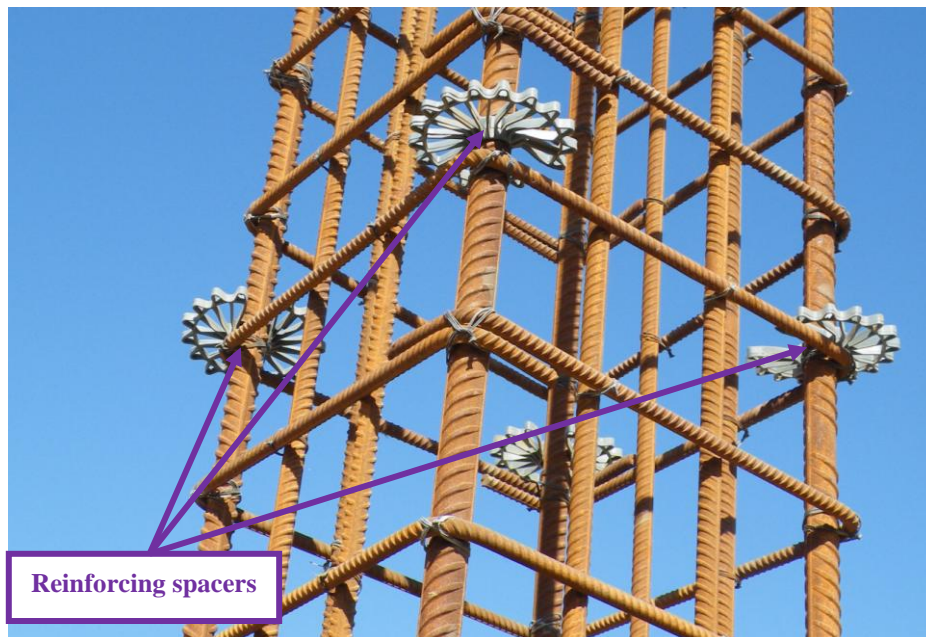
**Site Photo 6. Column reinforcing cage and form spacers**

Upon review of the reinforcing steel for the columns, SIGIR noted a wheel type of spacer used in the construction of the reinforcing cage (Site Photo 6). In general, the use of spacers to maintain adequate concrete cover over the reinforcing steel is a good construction practice. However, the configuration of the spacers SIGIR observed may prove to be problematic. Specifically, the contractor utilized spacer with radial spokes between the reinforcing bars and the outer edge of the spacer. The distance between the radial spokes appeared to be smaller than the maximum possible dimension of the aggregate in the concrete mix. During pouring operations, the spokes may become clogged, preventing concrete from completely filling the corners of the column below the spacer, which would result in voids and/or honeycombing at the corners of the columns.

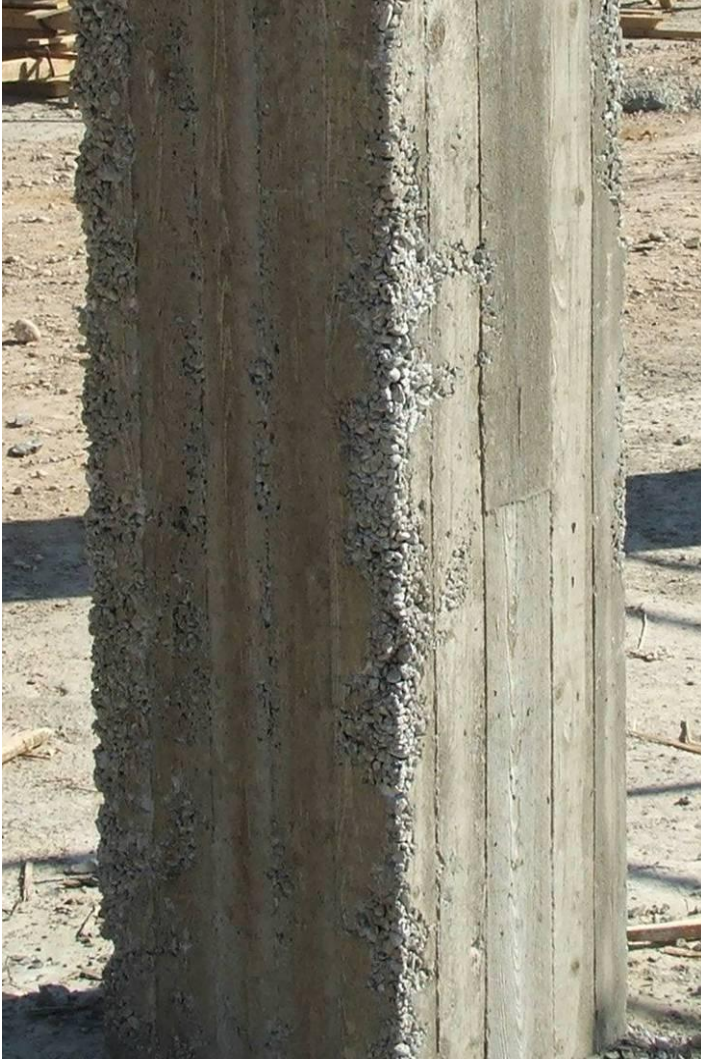
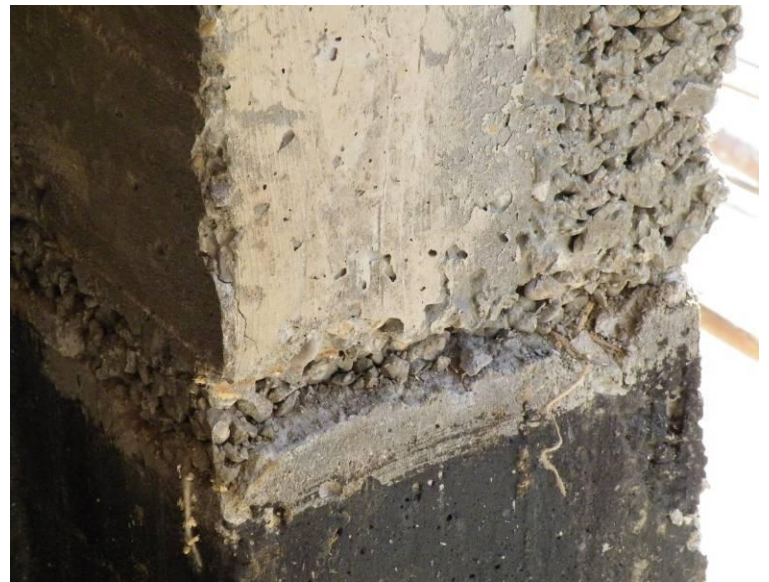
SIGIR identified several examples, from slight to moderate to severe, of honeycombing of the reinforced concrete members (Site Photos 7 and 8). This construction deficiency appeared to be most prevalent at construction joints between successive pours and along the corners of the reinforced concrete members.

**Site Photos 7 and 8. Typical examples of slight to moderate concrete honeycombing in columns**

Due to time limitations on site, SIGIR could not assess the extent and severity of the honeycombing, which may require limited destructive testing to ascertain. However, SIGIR did observe, in at least one location, exposed primary reinforcing steel (Site Photo 9). The full extent of the honeycombing should be assessed and appropriate remedial measures taken based upon the impact to each member.

3. Require the contractor to remove all defective concrete and replace it with a suitable repair material.
4. Require the local national on-site quality assurance representatives to closely monitor and ensure that the contractor removes and replaces deficient concrete.

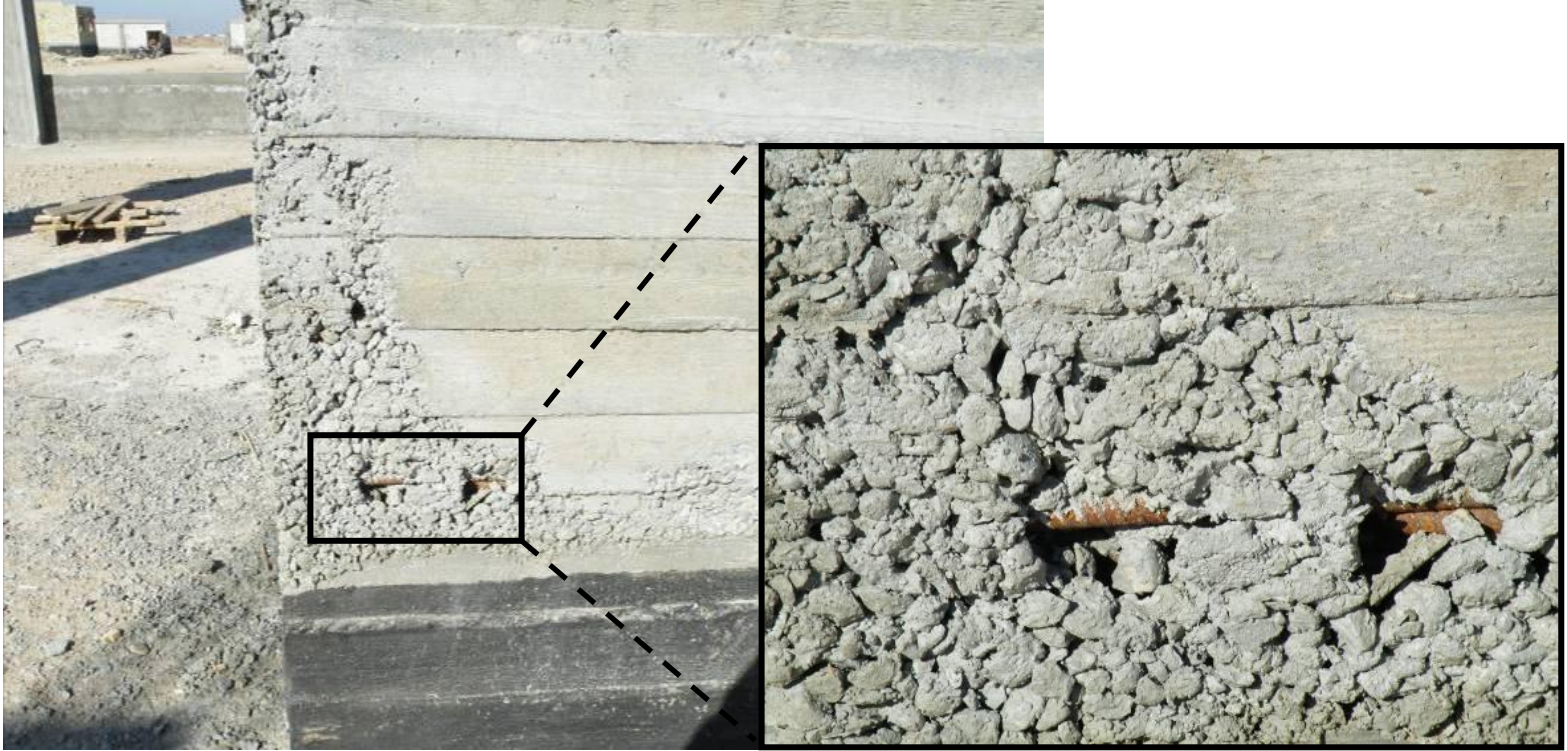
**Site Photo 9. Example of severe concrete honeycombing (including exposed reinforcement bar)**

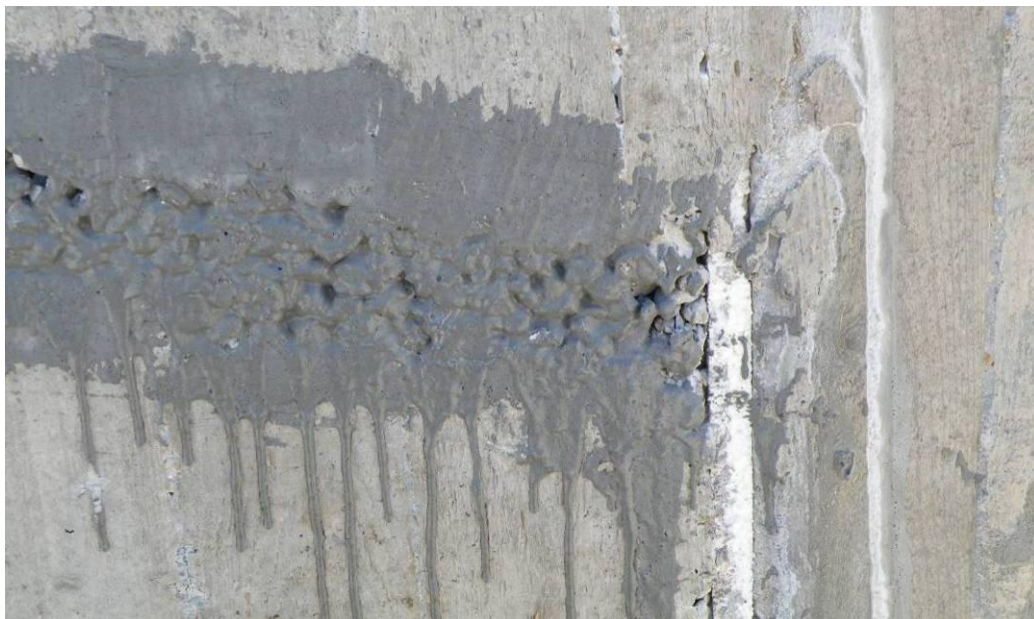
SIGIR noticed several instances where the contractor attempted to repair some of the honeycombed areas with low viscosity epoxy (Site Photo 10). Since the extent and severity of the honeycombing could not be ascertained, it is unclear if this is the appropriate repair method for these construction defects.

**Site Photo 10. Attempted repair of honeycombing utilizing low viscosity epoxy**

However, in most instances that SIGIR observed, this method appeared to be inadequate. For example, the contractor's repair attempt did not achieve complete infill of the visible void areas, and it is reasonable to assume that the epoxy did not reach the subsurface voids in the concrete.

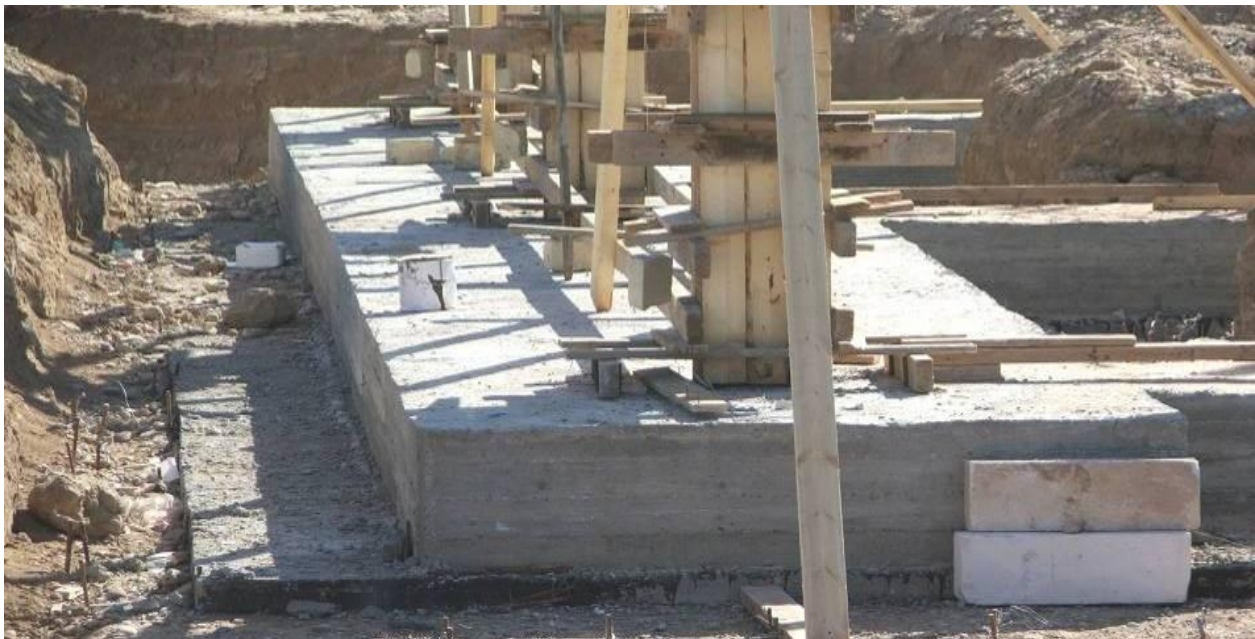
**Site Photo 11. Foundation prior to backfill**

At the time of the site visit, the foundation backfill had already been performed over a significant portion of the project site. Consequently, SIGIR was only able to inspect limited areas of the foundation (Site Photo 11).

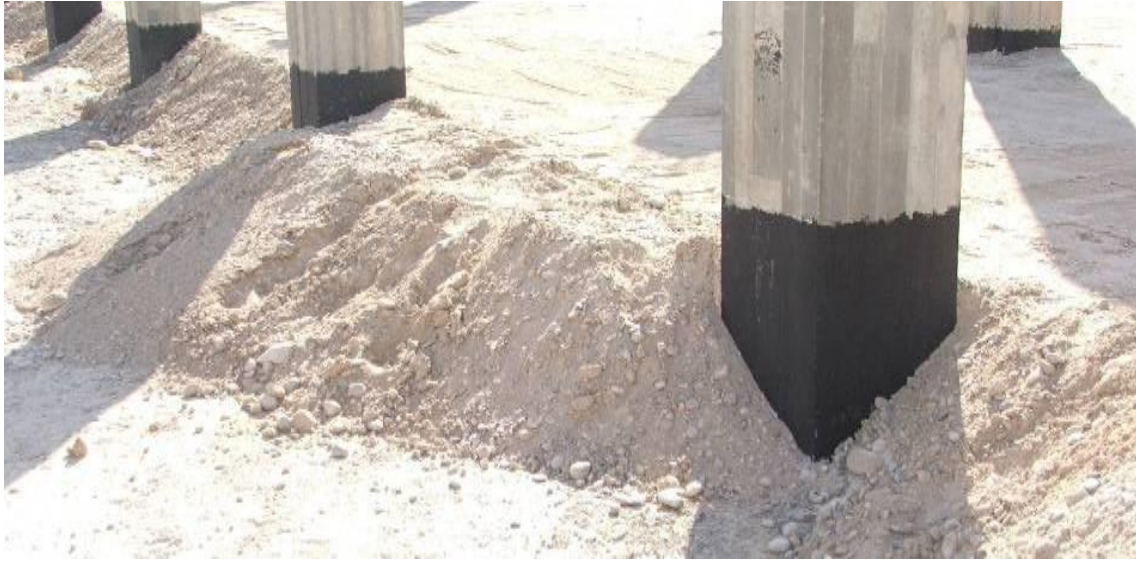
**Site Photo 12. Edge of backfill over foundation**

At the time of the site visit, backfilling operations were not taking place. SIGIR noted a lack of visible compaction layers at the edge of fill, which indicates the potential for inadequately compacted backfill (Site Photo 12).

SIGIR did not observe any watering equipment available on site, nor did it appear that the contractor was wetting the soil prior to compaction in order to obtain the optimum moisture content. Failure to obtain proper compaction could potentially result in cracking and/or settlement of the ground floor concrete slab.

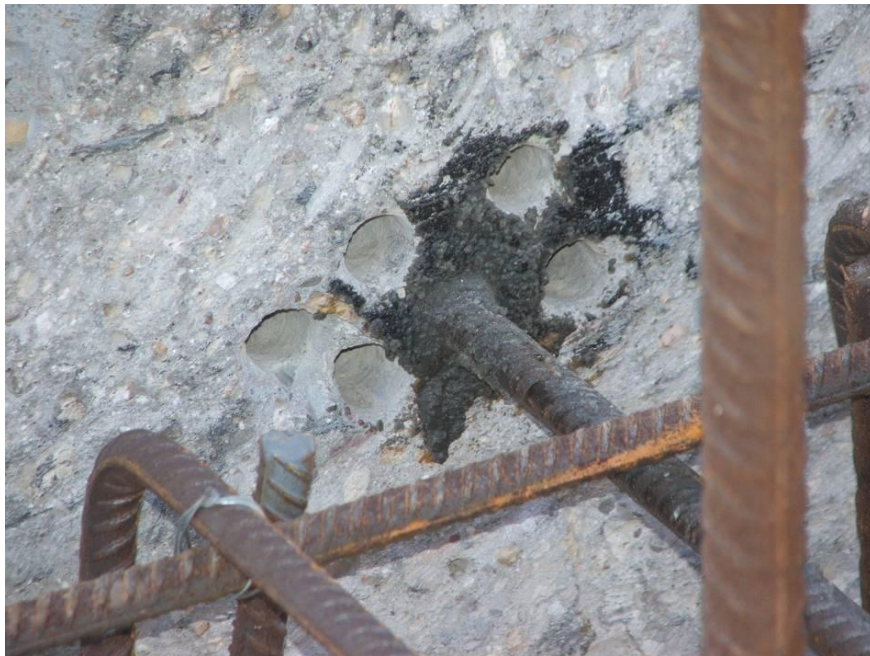
**Site Photo 13. Multiple holes surrounding epoxy anchored dowel**

SIGIR examined the footings and identified a series of miss-drilled dowel holes surrounding an epoxy anchored dowel pin (Site Photo 13). The close proximity of the holes to the anchored dowel has resulted in reduced strength at this connection. However, since this dowel is one in a series of several dowels along the face of the footing, the impact of the weakened connection to the strength of the overall structure appeared to be minimal.

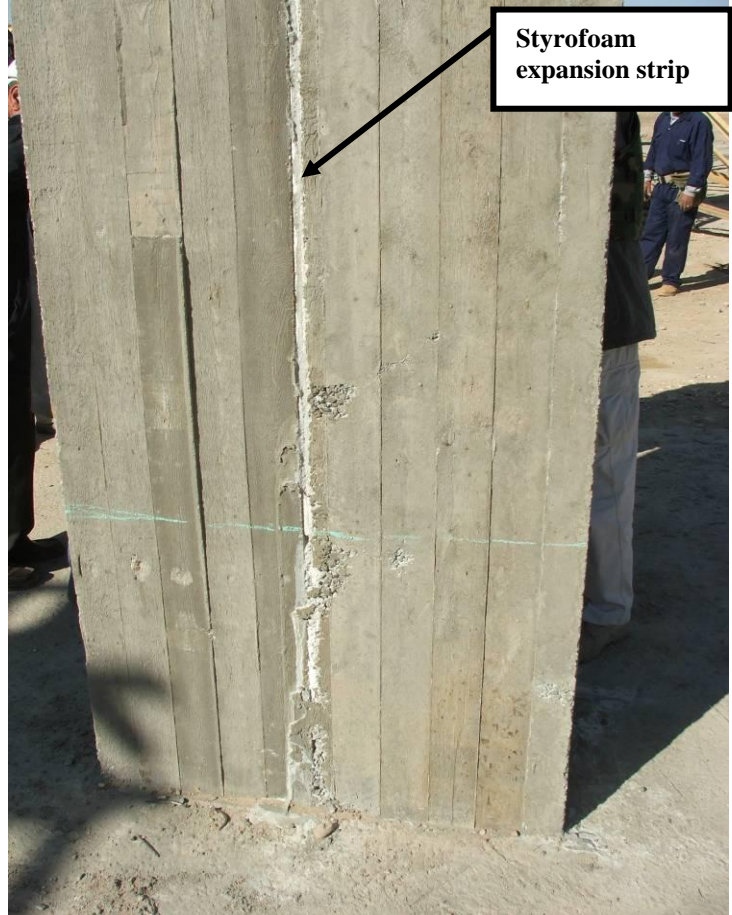
Site Photo 15. Example of Styrofoam expansion strip

The columns appeared to be constructed from independent concrete pours with Styrofoam expansion strip placed between the columns (Site Photo 15). While not the ideal material to use, Styrofoam will effectively isolate the columns along their length.

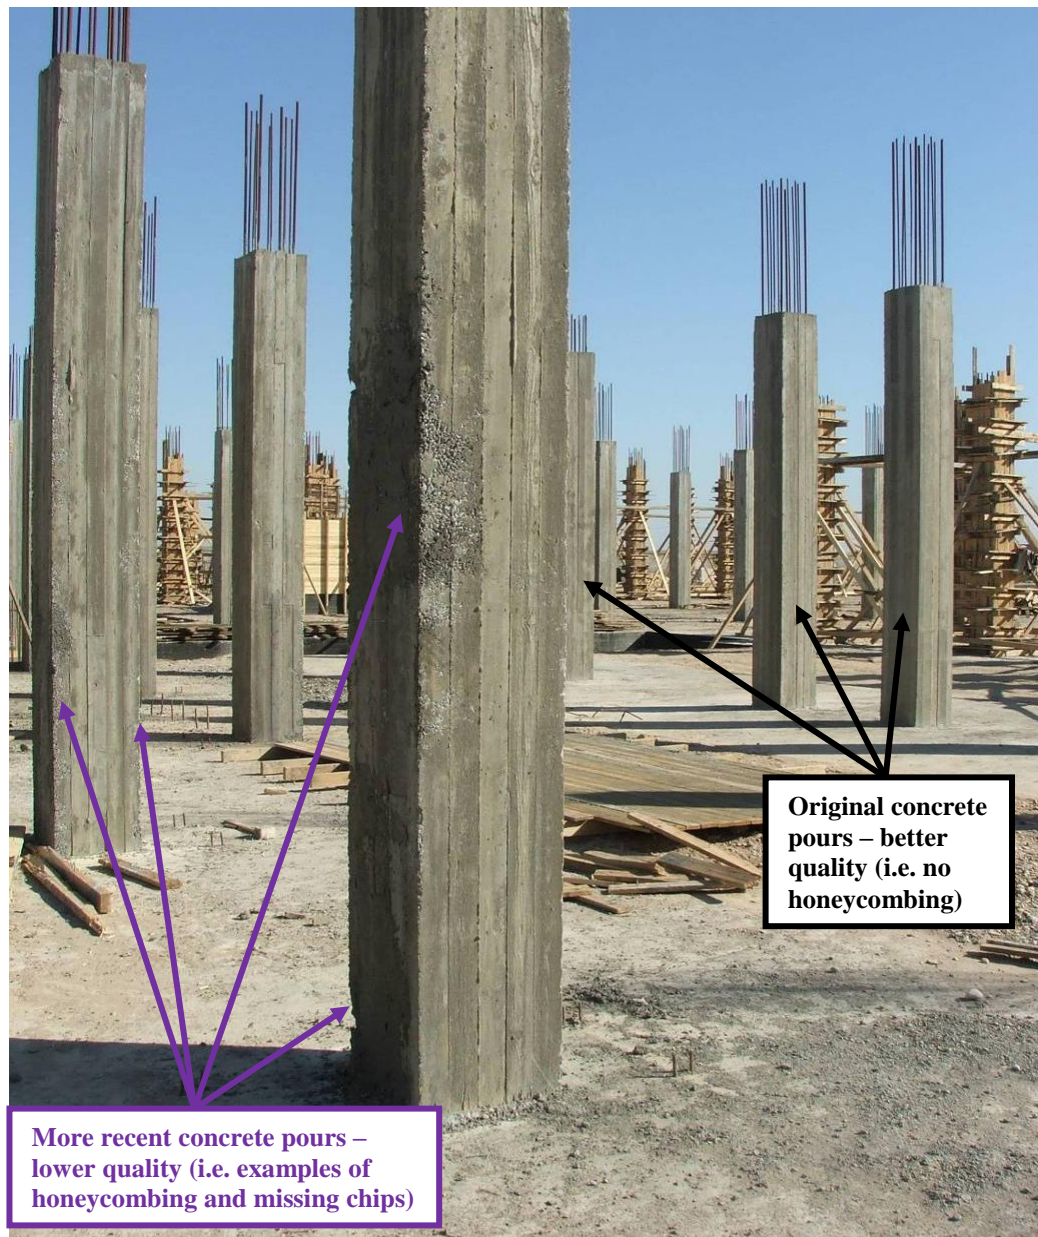
SIGIR noticed that the quality of the more recently constructed structural concrete columns was considerably less than some of the original columns (Site Photo 16). There is the possibility that contractor efforts to expedite the project may have led directly to concrete quality issues. For example, in an effort to increase productivity, the contractor probably pulled the column formwork too quickly and failed to adequately clean it prior to the pouring of the next column. Pulling the formwork before it is completely dry and not adequately cleaning it will significantly affect the quality of the next formwork concrete pours. SIGIR mentioned this to the GRS AAO representatives, who agreed that the more recent concrete quality issues could be due to the contractor being asked to follow a more expedited construction schedule.

Site Photo 16. Example of difference in concrete quality from more recent concrete pours

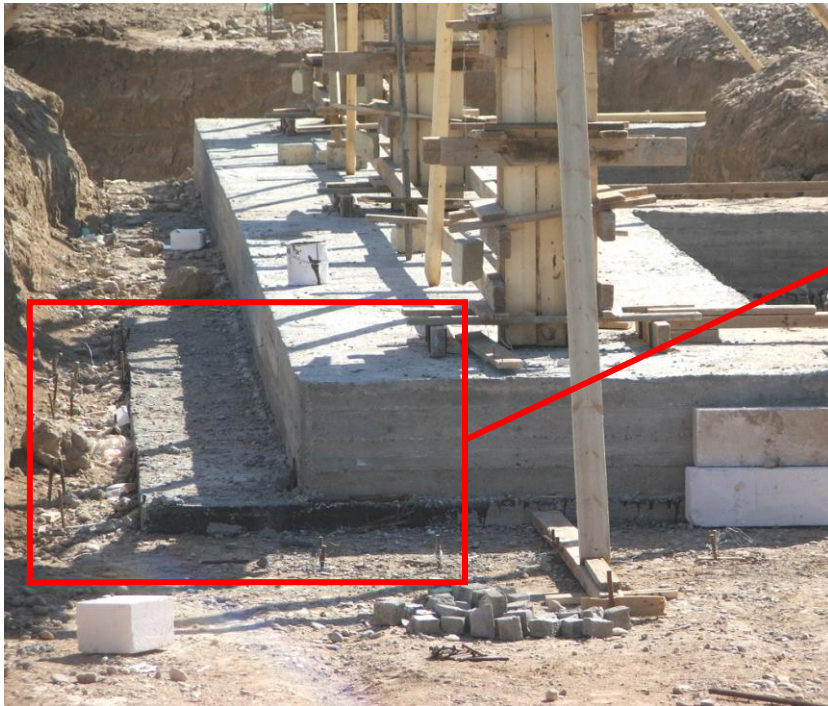
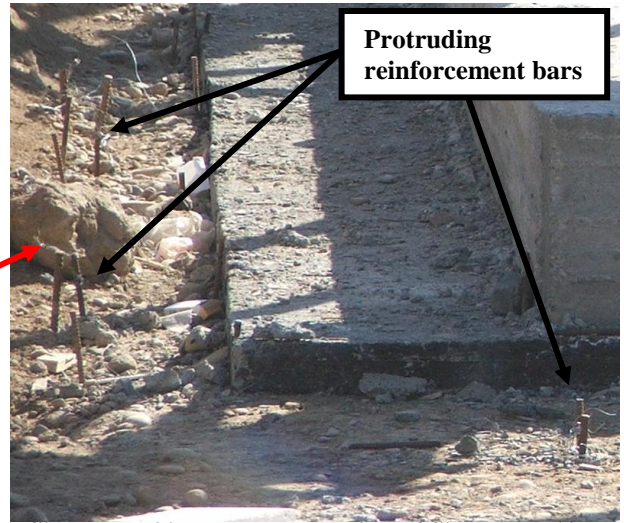
**Site Photo 19. Examples of protruding reinforcement bar**

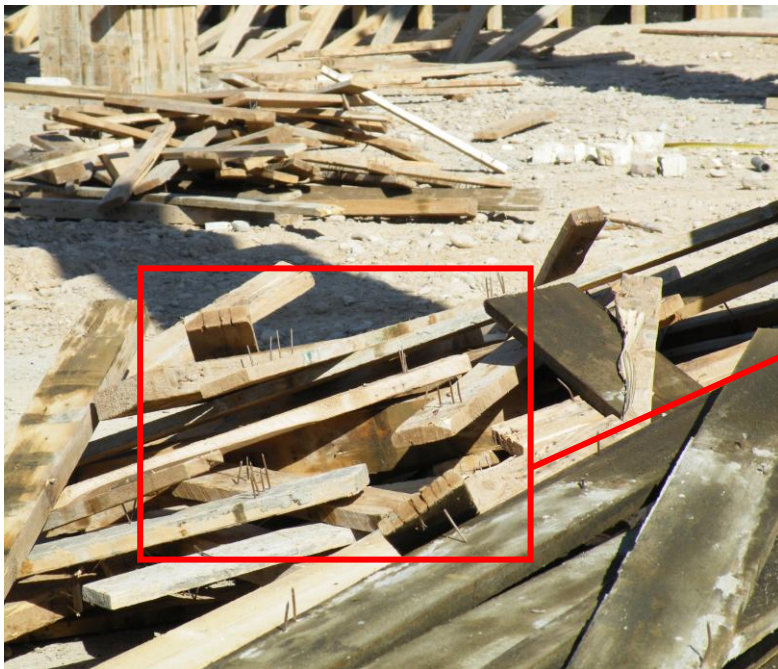
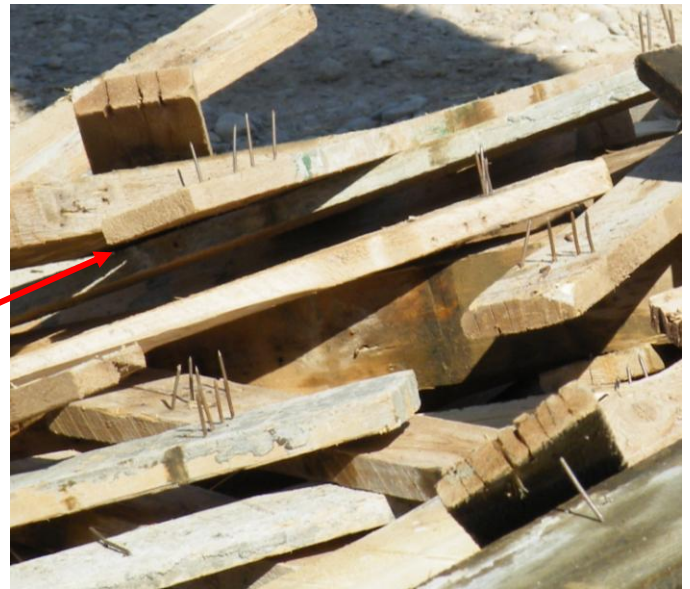
**Site Photo 21. Example of protruding nails**
